Aptos Creek Watershed Assessment Geomorphology & Sediment Source Assessment

prepared for: Coastal Watershed Council

prepared by: Swanson Hydrology & Geomorphology

December 30, 2002

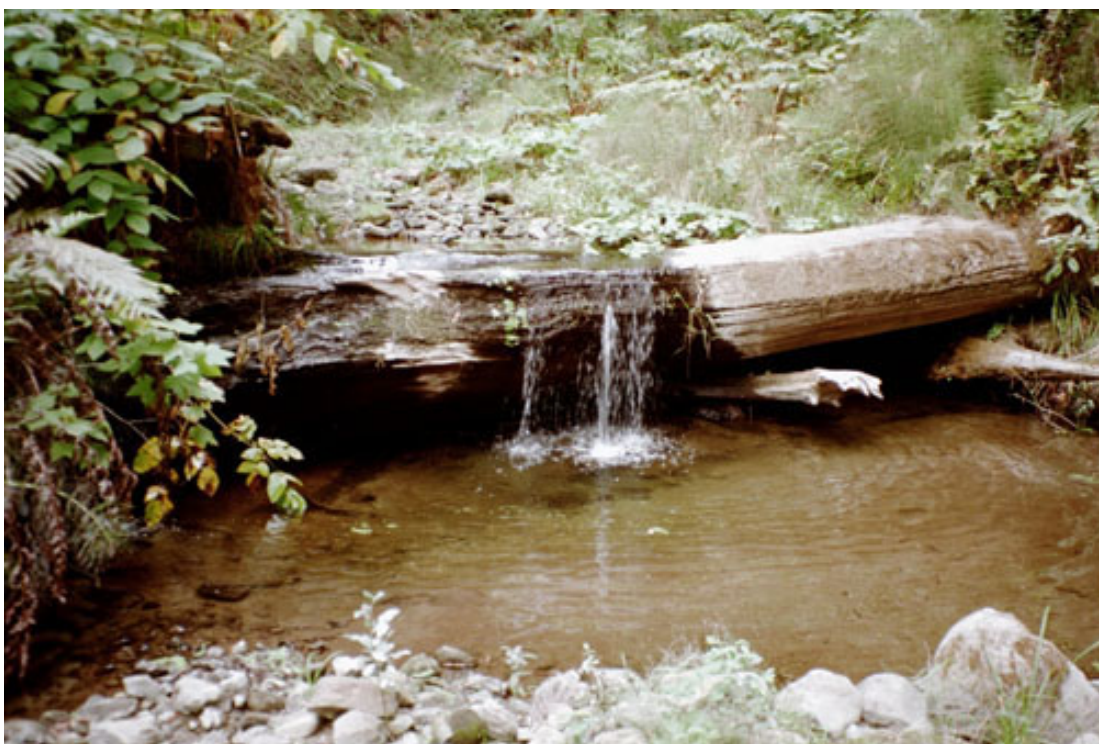
This is an example of woody material resulting in storage of coarse and fine material within the channel. Storage is likely to occur for approximately 100-200 feet upstream of the log.

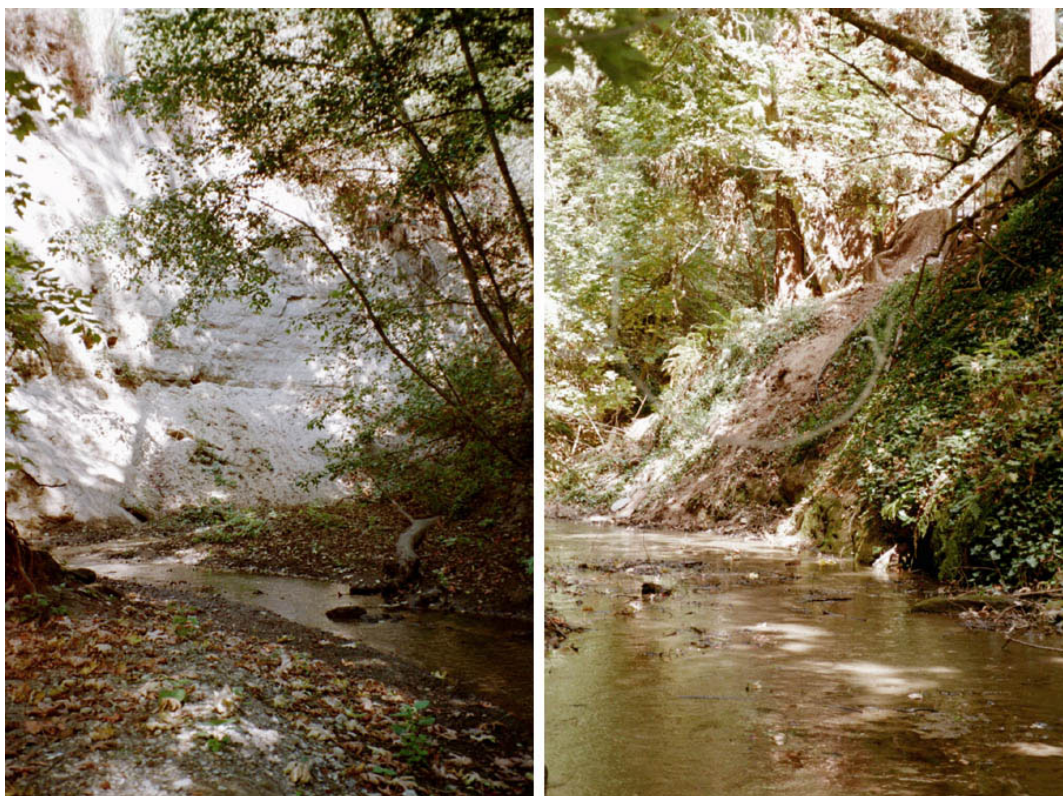
Mass wasting on Aptos and Valencia Creeks. Both are chronic sediment sources. The one on the left appears to be natural, caused by undercutting in the outer bend of a meander. The photo on the right is clearly related to development occurring at the top of the hillslope.

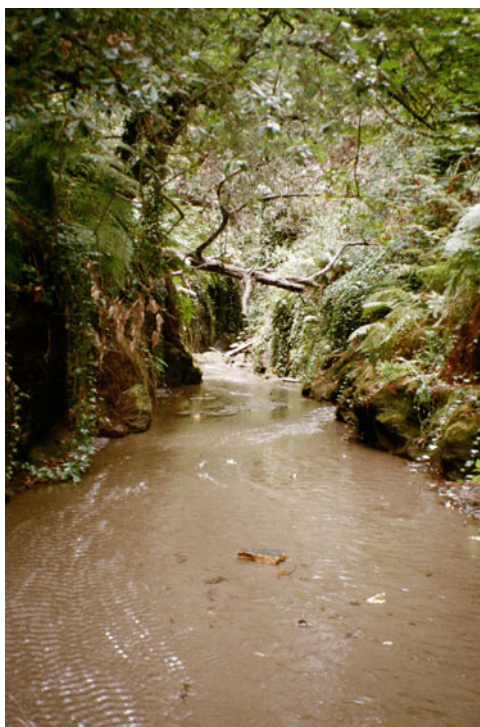
Shallow sandy bed on Valencia Creek.

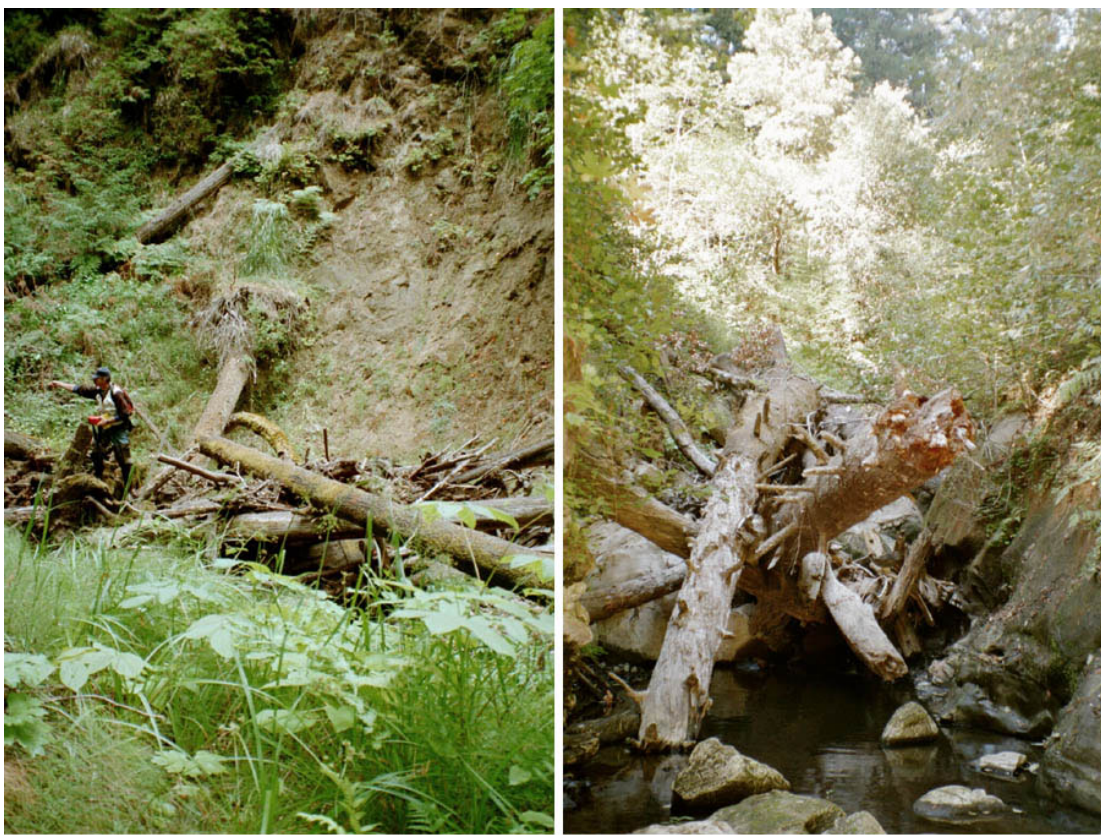
Examples of large woody debris jams found in the upper watersheds of Aptos and Bridge Creeks. In the photo on the left, the jam appears to be associated with a shallow landslide. On the photo on the right, a narrow bedrock section backs up both wood and sediment, creating a potential fish barrier.
